RESTORATION OF THE VAN ALLEN HOUSE

THE BOROUGH OF OAKLAND, NEW JERSEY

John M. Dickey, A.I.A.
Architect

April 1977

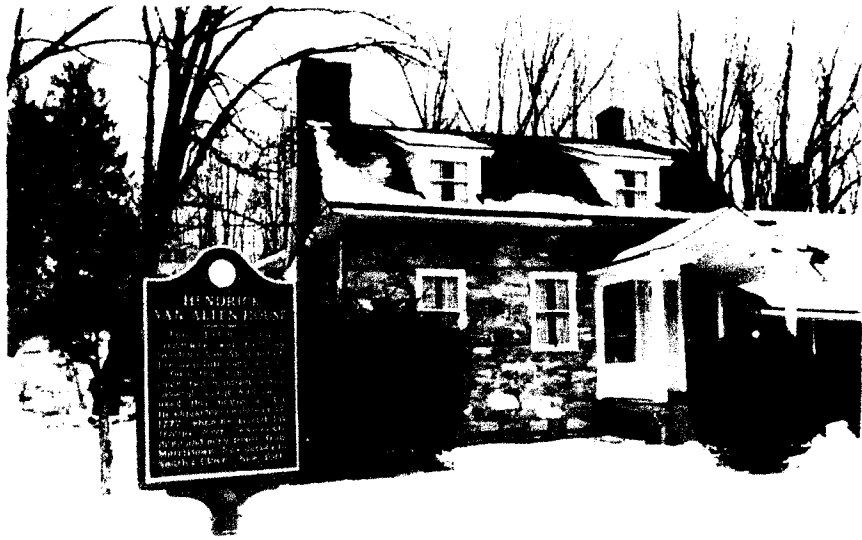
Photograph 1 South Elevation
Original increment showing later Page alterations.

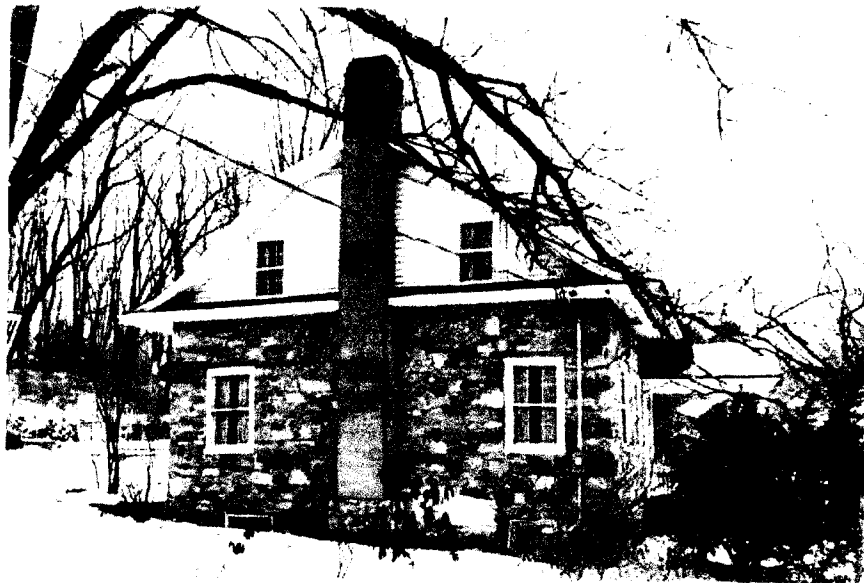
Photograph 2 West Elevation
Original increment showing Page alterations to
gable end and modern concrete chimney.

During the twentieth century modifications included removal
of the frame wall on the south elevation of the second addition
to permit the extension of the room, ^{BY MEANS OF CONCRETE WALL THAT IS EXPOSED} the enclosure of the
remaining porch in front of the first addition, and the construc-
tion of a concrete chimney on the west end of the original
increment (Photograph 2).

- A) Remove concrete chimney on west end of the building
- B) Repoint Exterior
- C) Replace Rotted Miscellaneous Millwork
- D) New Clapboards on Gable Ends

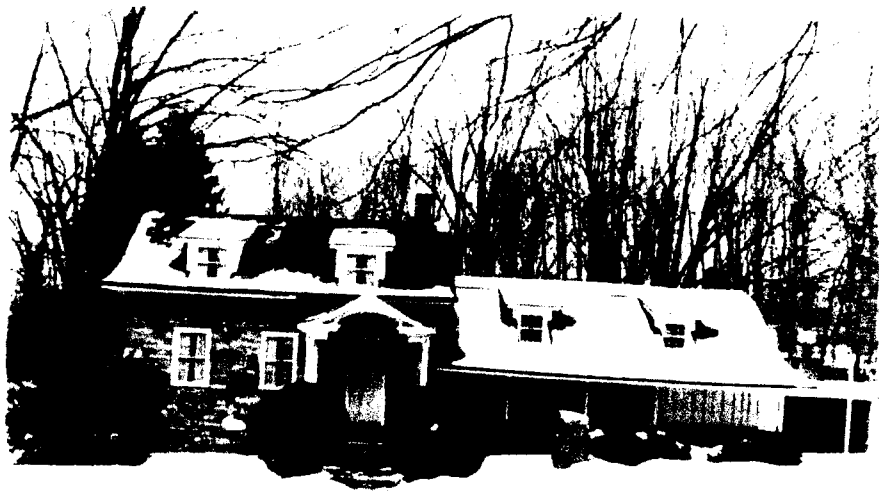
Photograph 3 South Elevation
Original increment, first and second additions
FRONT

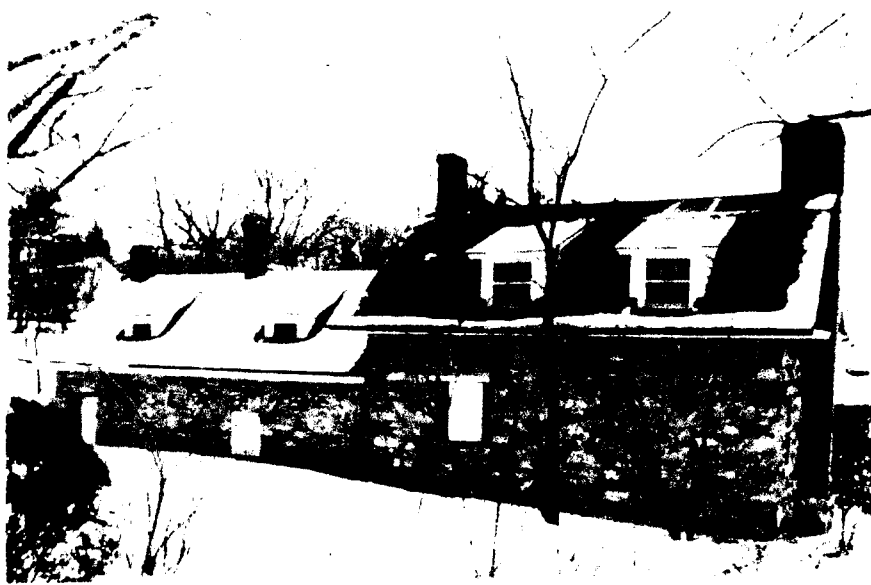
Photograph 4 North Elevation
Original increment, first and second additions
REAR

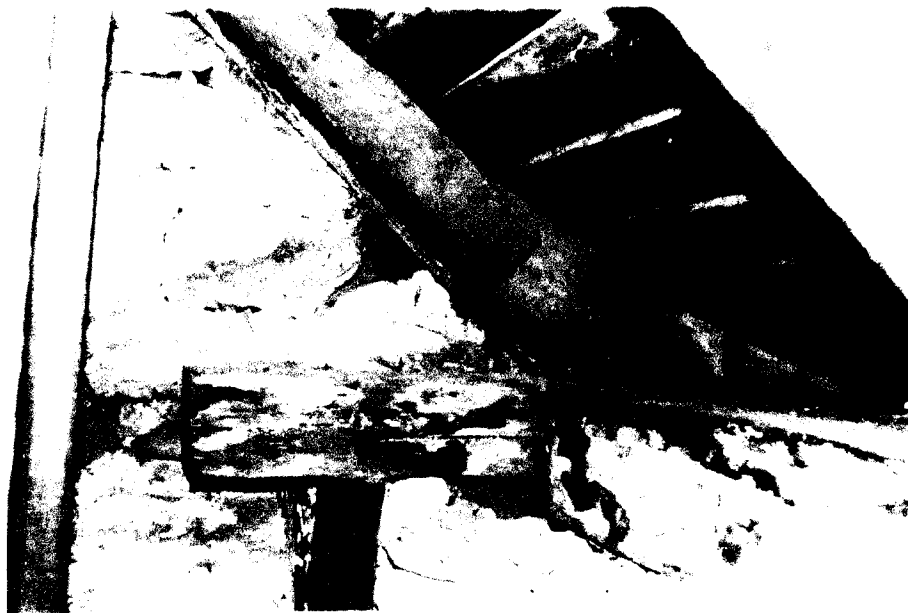
Photograph 13

Interior view of west end of first addition, second floor (attic). The rafter (beyond) and tie member at the plate are framing members of original gable roof.

placed, but the heavy hewn plates remain and the trace of the original rafter is clear where it joined the first increment (Photograph 13). The change to a gambrel is unquestionably early twentieth century, since the nineteenth century porch roof still exists under the new porch roof.

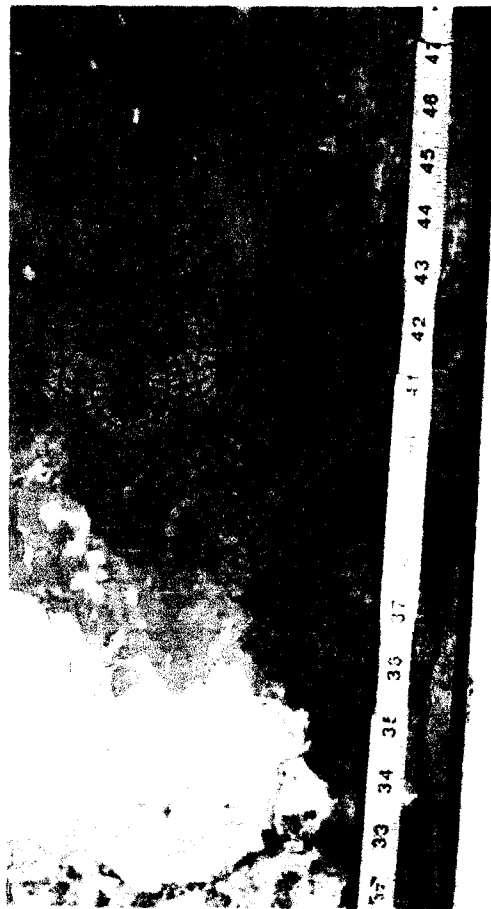
Photograph 15

Kitchen, first addition, southeast corner at former fireplace. Uppermost layer of nineteenth century wallpaper.
