RESTORATION OF THE VAN ALLEN HOUSE

THE BOROUGH OF OAKLAND, NEW JERSEY

John M. Dickey, A.I.A.
Architect

April 1977

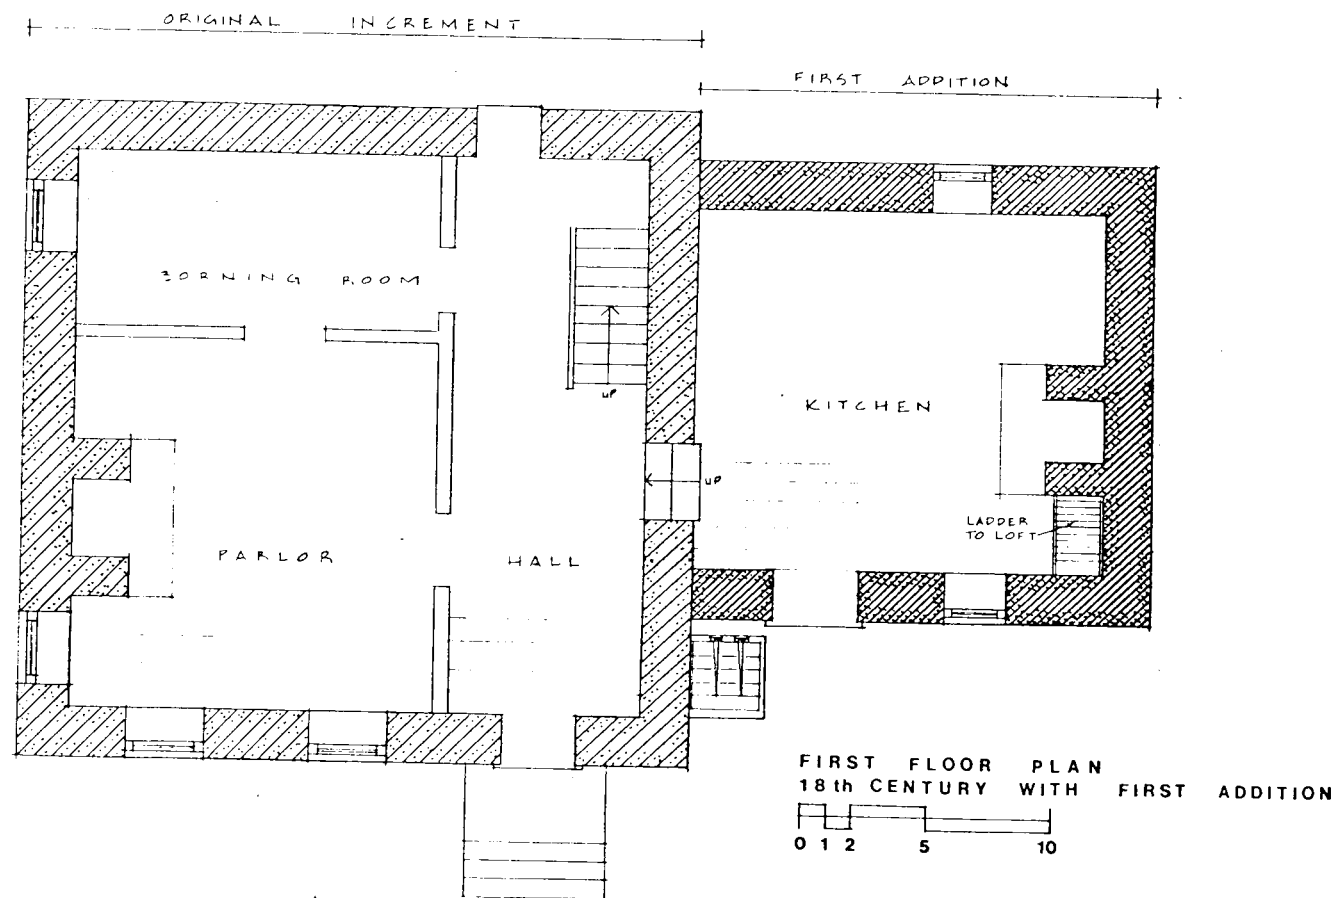
FIG. 5

The first addition to the east, a kitchen at a lower floor level, was built soon after the original increment (Fig.5; Photographs 3 and 4). The building techniques used in the addition, particularly in masonry and plaster, are similar to those employed in the first increment. The joint of the exterior walls shows clearly that the western rectangle existed for a time as an independent building (Photograph 5). The first addition had a gable roof and an independent stair or ladder at one side of the cooking fireplace on the east wall (Photograph 6). There is no trace of an opening between the second floors of the first addition and the original increment. The trace of the original gable roof is visible against the common wall (Photograph 7). The second addition, east of the first, was built much later, probably in the second half of the nineteenth century (Fig.8). A curious combination of masonry and frame walls, this addition formed the east end of the house for some years, as shown by

The physical evidence in the building fabric of the Van Allen house is unusually diverse, and lacking any documentary assistance at this time provides a confusing picture. It appears that the (MAIN HOUSE - WEST) first increment and the (KEEPING ROOM) first addition (Fig. 5) were built in the mid-eighteenth century, probably not more than a generation apart, and undoubtedly both increments existed at the time of the Revolutionary War. After the war, perhaps as early as 1800, the two increments were divided and inhabited by separate families for many years. Toward the middle of the nineteenth century the (MAIN HOUSE - WEST) original house was allowed to deteriorate over many years, until its roof and second floor structure was at a point of collapse. In all probability the original chimney failed first and brought the rest of the structure down with it. During this period the (KEEPING ROOM) first addition was inhabited, refinished periodically, and kept intact structurally.

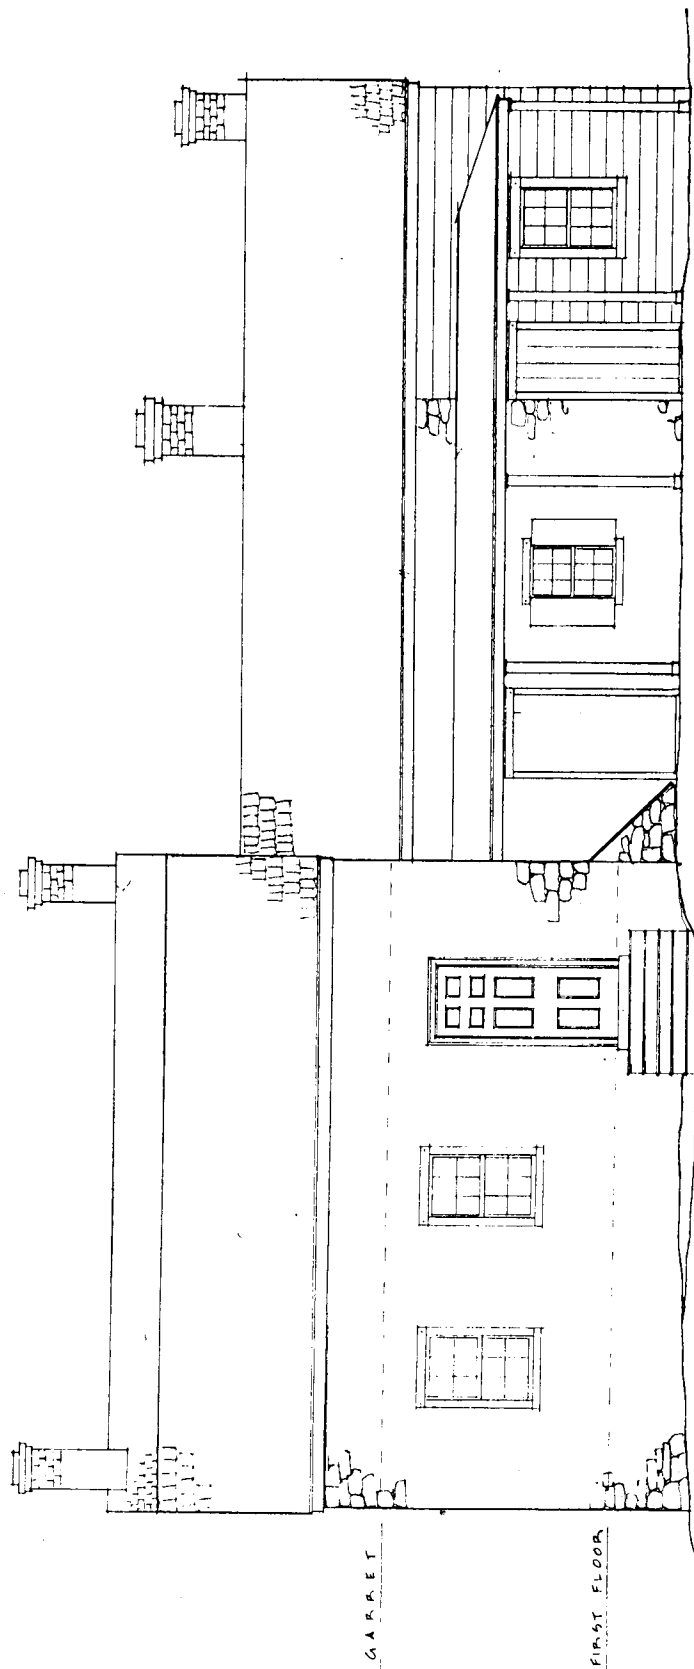
FIG. 9

the hipped end of the hidden porch roof (Fig.9), it was soon followed by a series of further additions to the east, which appear in the early photographs, but which have since been removed. ^{THIS IS CORRECT →} A new chimney on the east wall without a fireplace indicate this addition was also built for kitchen purposes, this time with a cook stove.

SOUTH ELEVATION
19th CENTURY WITH SECOND ADDITION

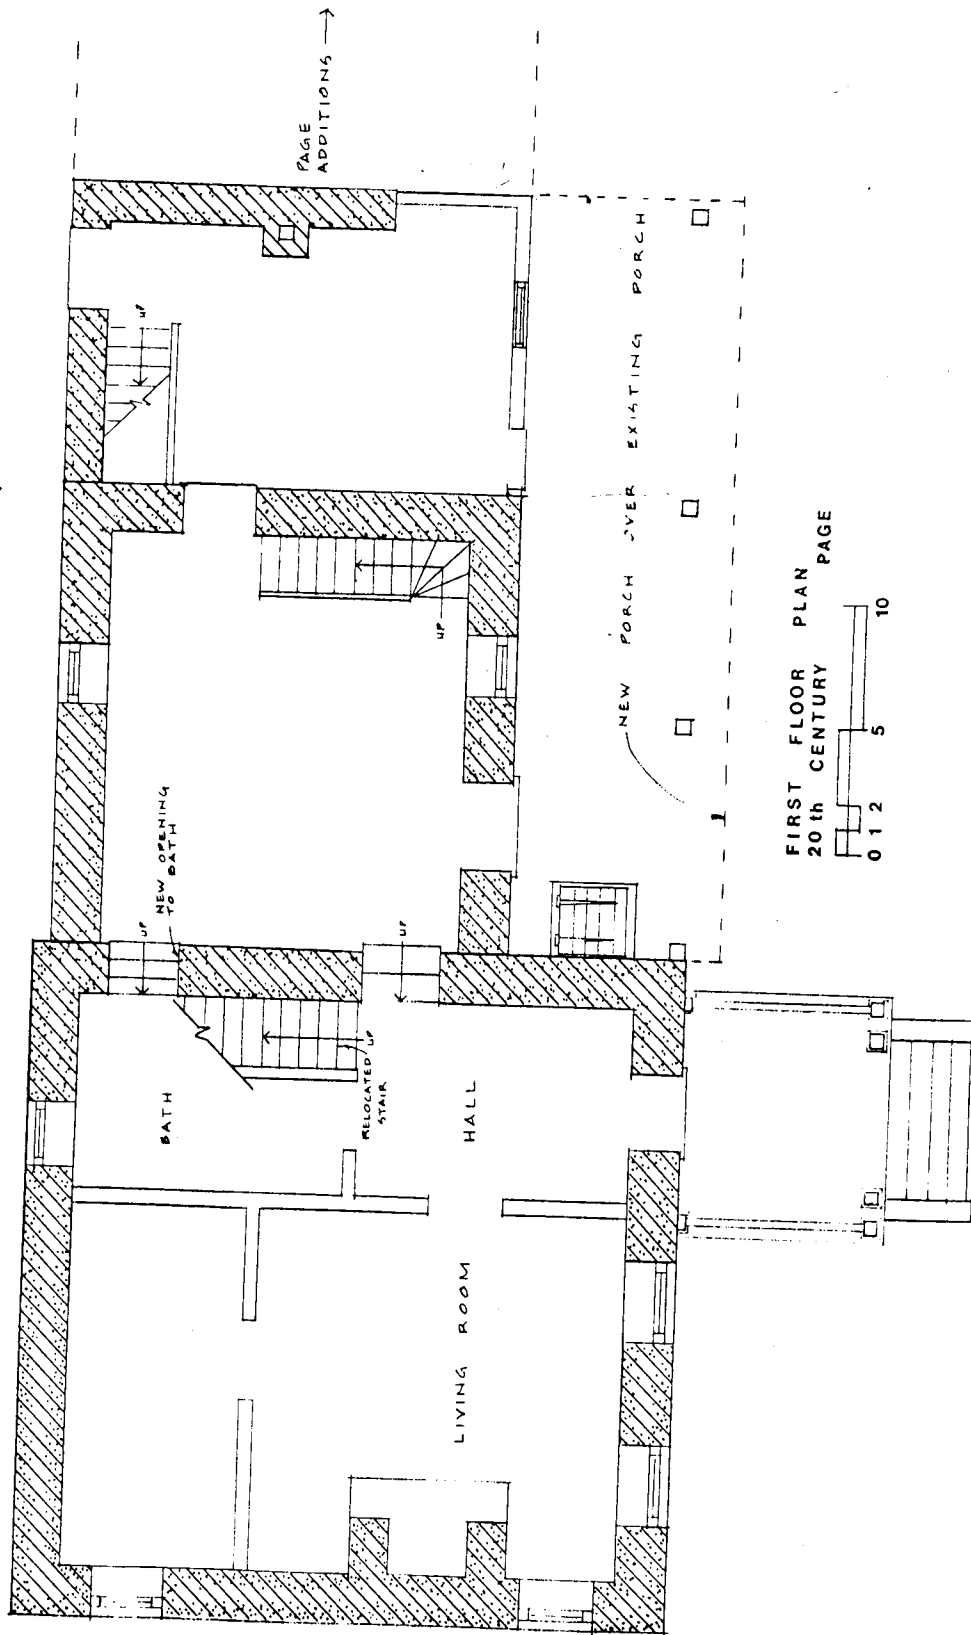
FIG. 11

remodeling includes the overhang of the roof on the original
(EAVES)
increment, the construction of the gambrel roof on the addition,
the front porch, the second floor partitions, and the construc-
tion of a long range of buildings connected to the east end of
the second addition (Figs. 11, 12, and 14).
STONE WORK FROM THE WEATHER

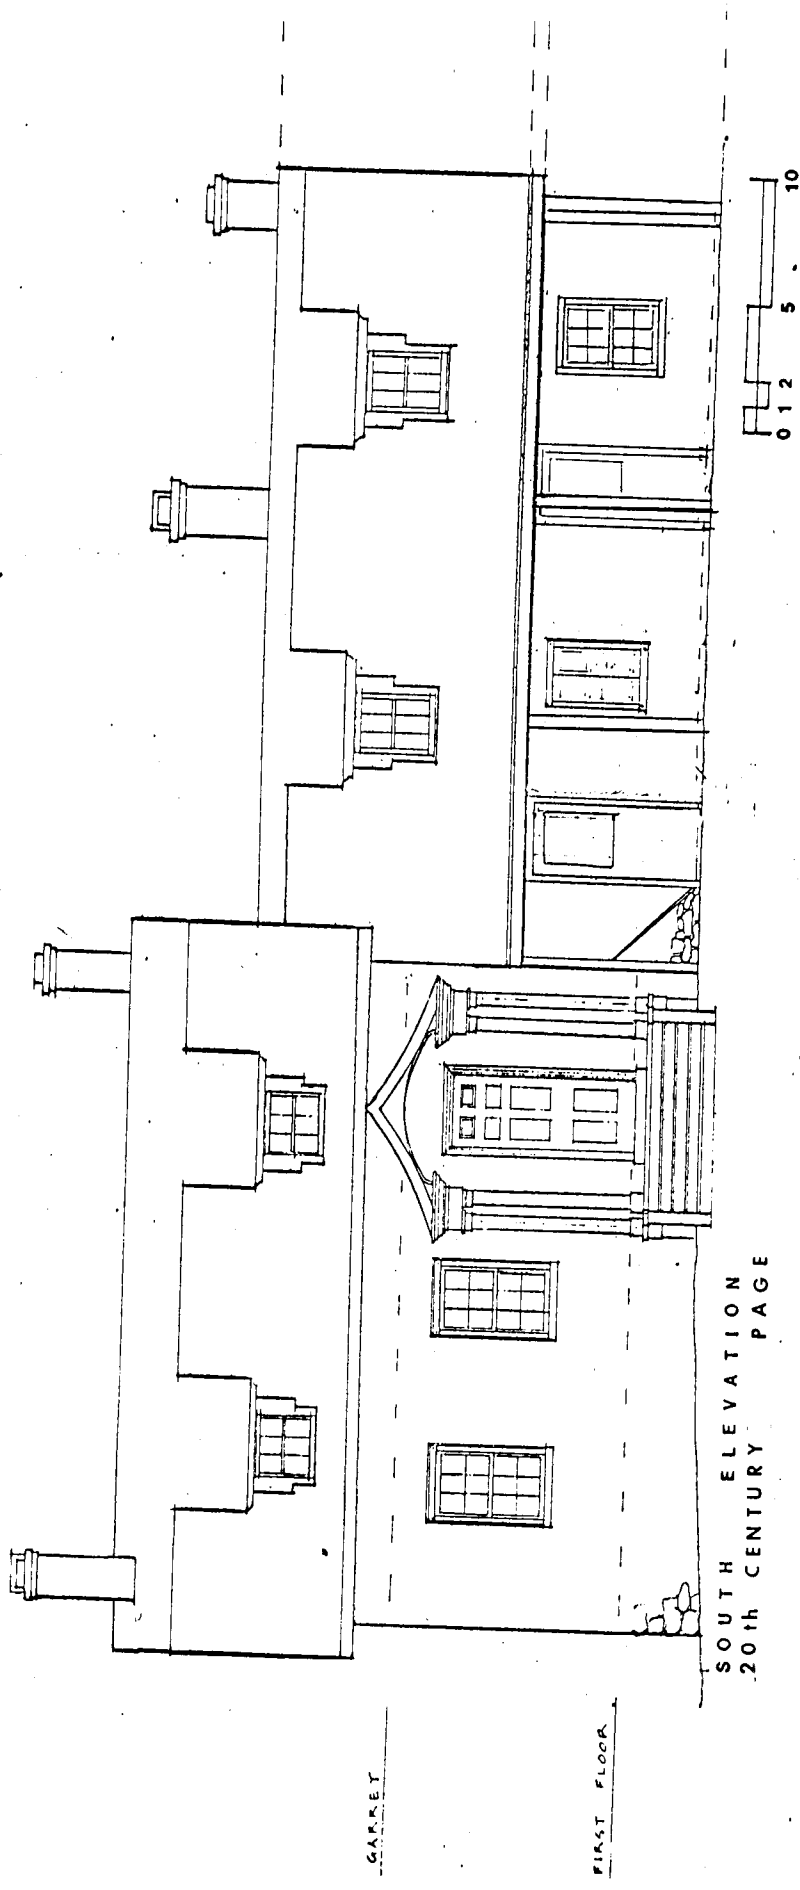
FIG. 12

SOUTH ELEVATION
20th CENTURY PAGE

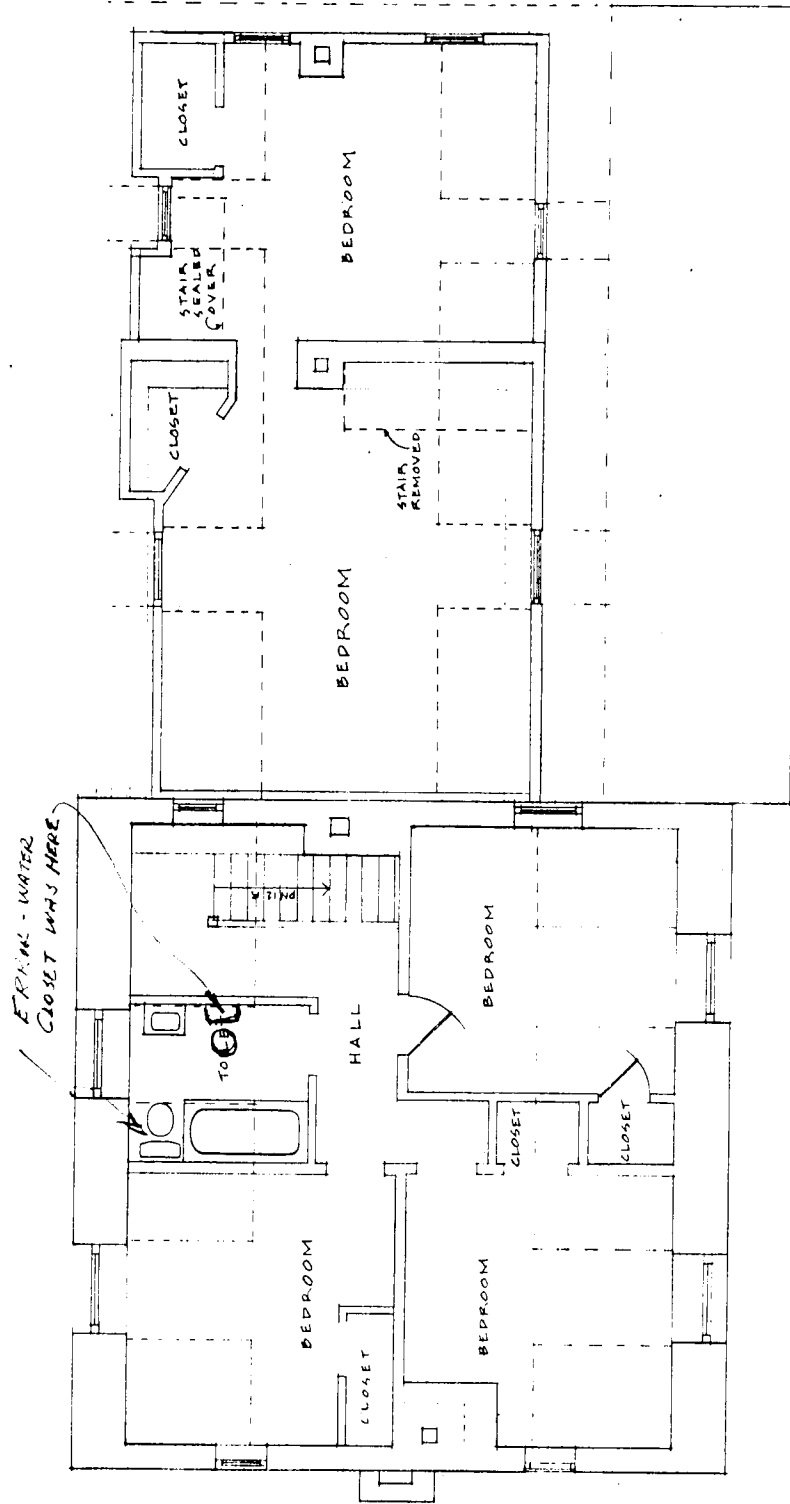
FIG. 14

SECOND FLOOR PLAN
EXISTING CONDITIONS
